Project

LONDON ARRAY HV3 EXPORT CABLE REPAIR

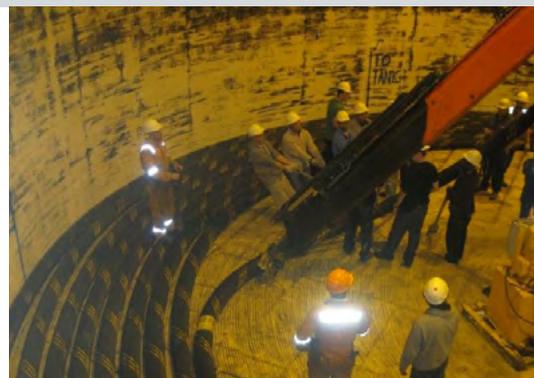
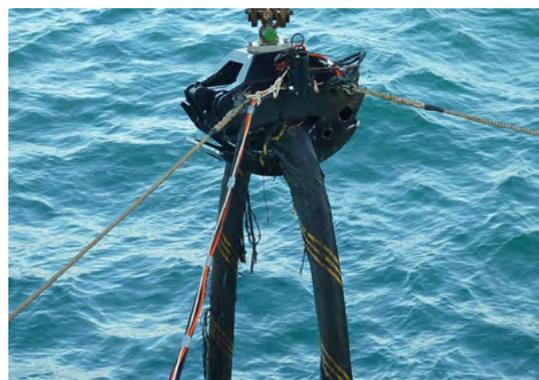
Design Fabrication and Implementation of Specialty Tooling

The 800mm² HVAC cable has a 218mm diameter and weighs over 150kg/m in water and 86kg/m in air. Tools for handling the large stiff cable did not readily exist in the market and standard grapnel operations were not possible due to nearby cable routes. In addition to securing a trenching ROV and mass flow excavator, Pharos Offshore was able to expedite the fabrication and modification of commercially available off the shelf technology to meet the unique projector requirements. This specialty tooling included: remote actuated spreader bar, cable grabber, cable tank loading arm, cable cutter, stern chutes, rollers, powered quadrants and more.

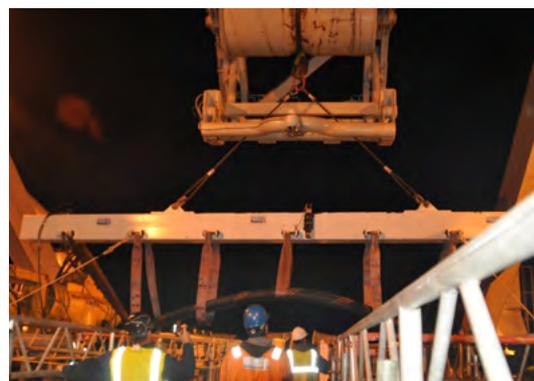
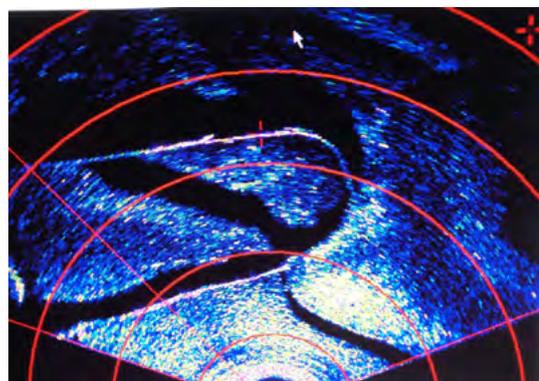
Cable Location, D-Burial and Recovery

Pharos developed multiple operational plans that not only met the client's tight schedule, but allowed for the infield flexibility to deal with as-found conditions. These procedures included Safety Practices, Risk Assessment, Mobilisation, Demobilisation: as well as Cable Loading, Testing, Acceptance, Recovery, Route, Engineering, Installation, Burial and Final Survey. Once located, the cable required non-invasive de-burial with special excavating equipment so that both ends could be captured and recovered to deck. The special cable grabber was fitted with positioning, proximity switch, camera and lights to aid in low visibility, high current conditions without the need for diver assistance.
